# 'A State of Things Which Ought Not to be Permitted': Excavation of 19th-century slums (Bull Yard, Horn Yard, Swan Yard and Market Alley) surrounding Bank Street at 'The Charter', Gravesend

*Ashley Tuck*

Nineteenth-century remains in Gravesend (Kent, UK) were revealed by excavation, chiefly comprising buildings, along with wells and cesspits. Historic maps, newspaper archives and other sources have been used to interpret the majority of the site as a low status 'slum' accessed from narrow pedestrian passageways (Bull Yard, Horn Yard, Swan Yard and Market Alley). These areas comprised a poorly planned mixture of dwellings and premises including slaughterhouses, piggeries, warehouses and other commercial and small-scale industrial properties. A newspaper account described a view of the interiors of dwellings glimpsed through broken windows on Market Alley as 'A state of things which ought not to be permitted' (Gravesend and Dartford Reporter, 12 July 1879). Some parts of the site (Bank Street and Queen Street) were occupied by higher status dwellings and premises, including a medium-sized coach factory.

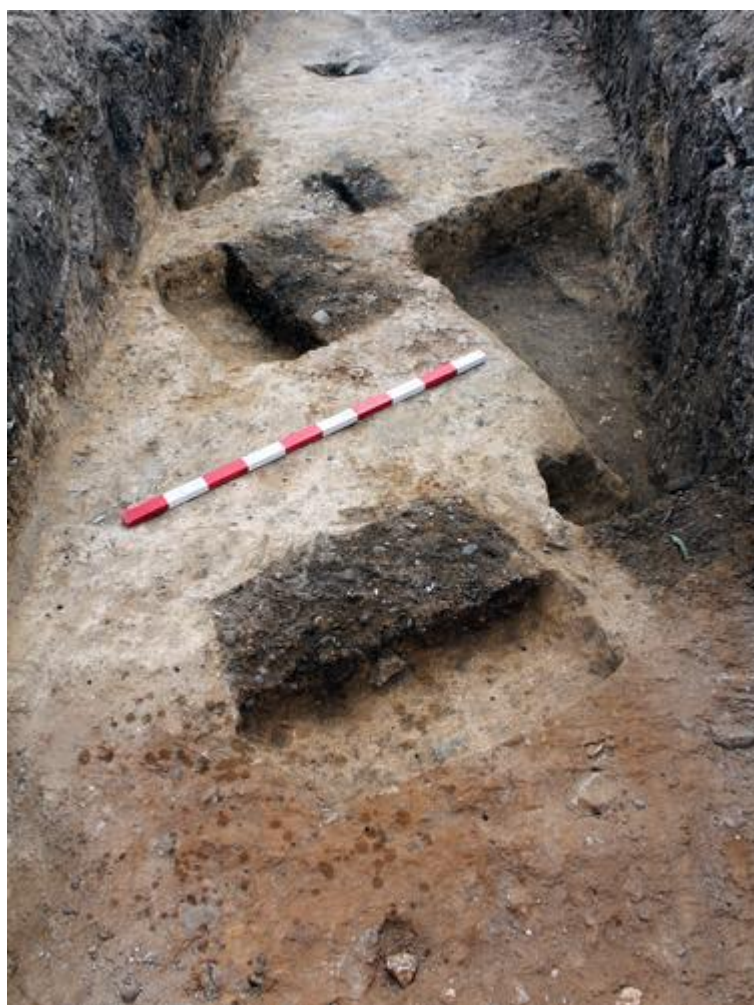
Figure 3: Group shot of pits 229 and 237 and postholes 231 and 235. 1 x 1m scale. View from south-east

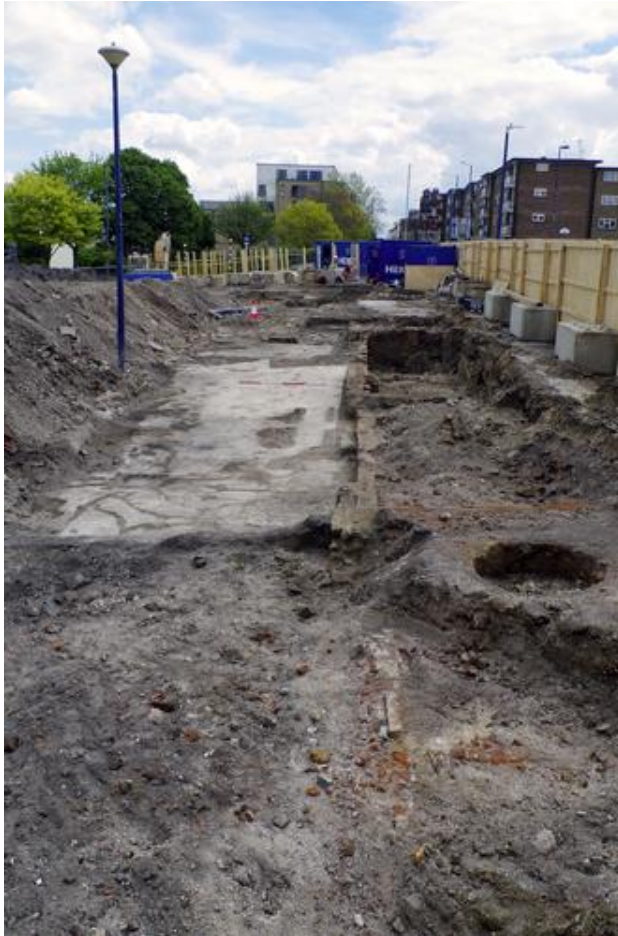
Figure 12: Cellars north of Bank Street (1178, 1179=308, 1168 etc.) with well 1174 in foreground. View from west

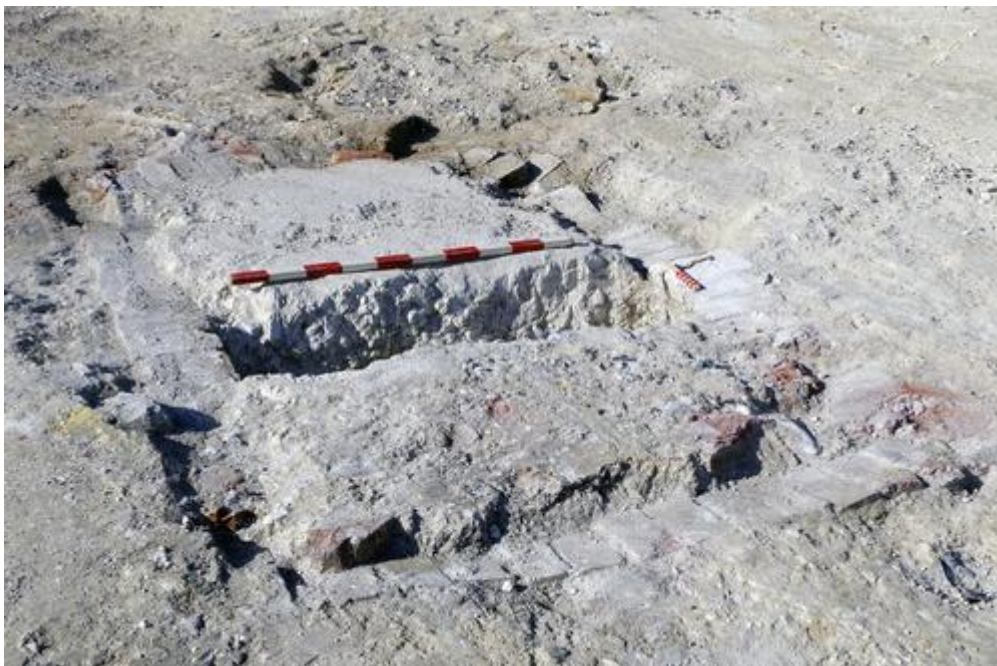
Figure 13: Tank 1016. 1 x 1m scale. View from north-east

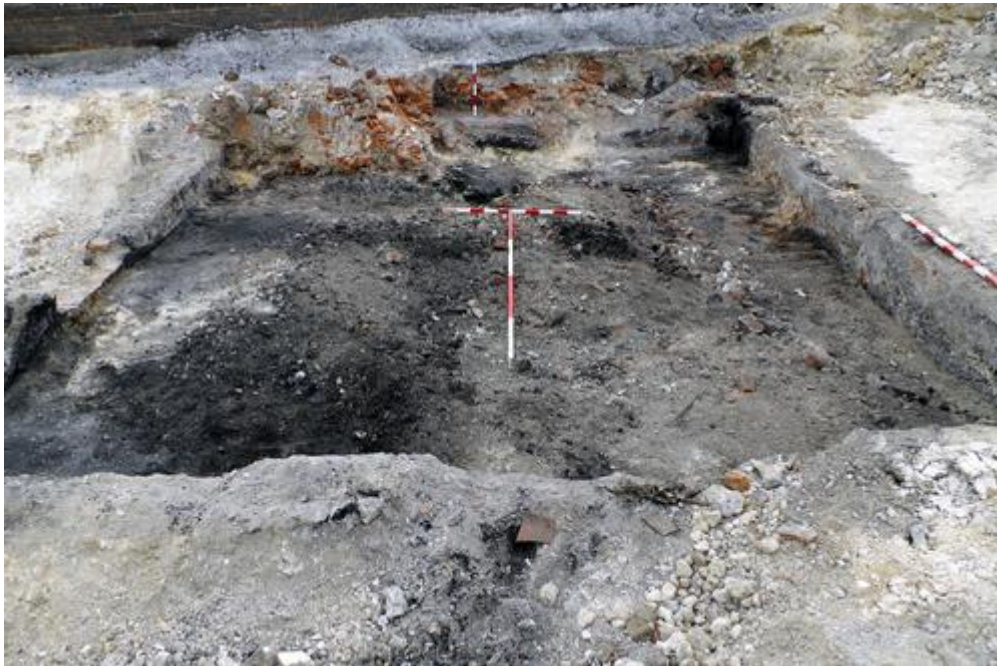
Figure 14: Cellar 1005=808 showing unusual concrete lining. 1 x 0.8m scale, 2 x 1m scales and 1 x 2m scale. View from east

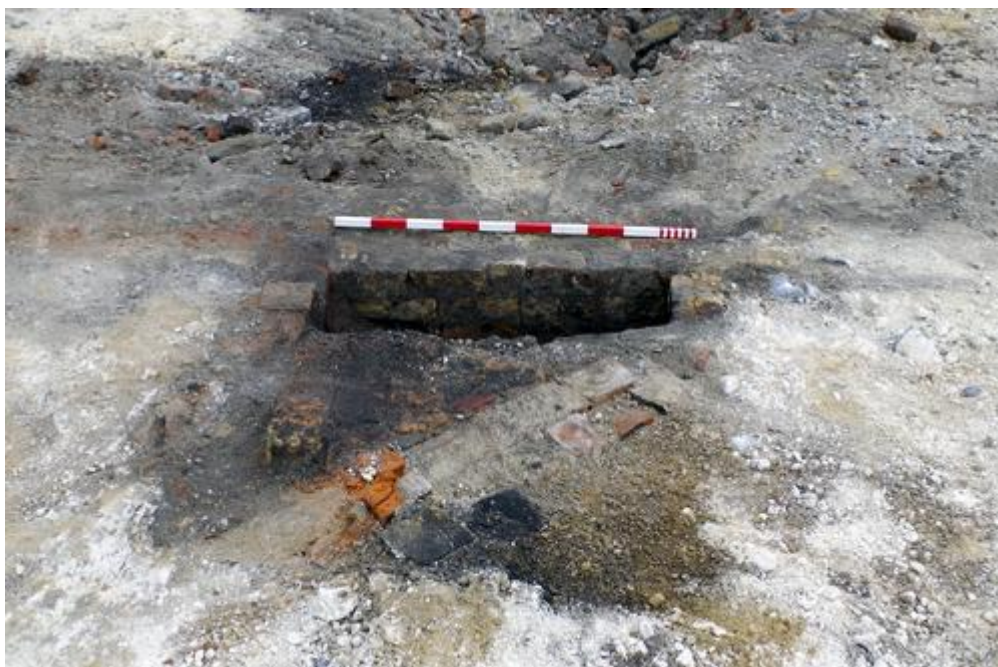
Figure 15: Staircase accessing cellar 1050 with treads removed. 1 x 1m scale. View from south

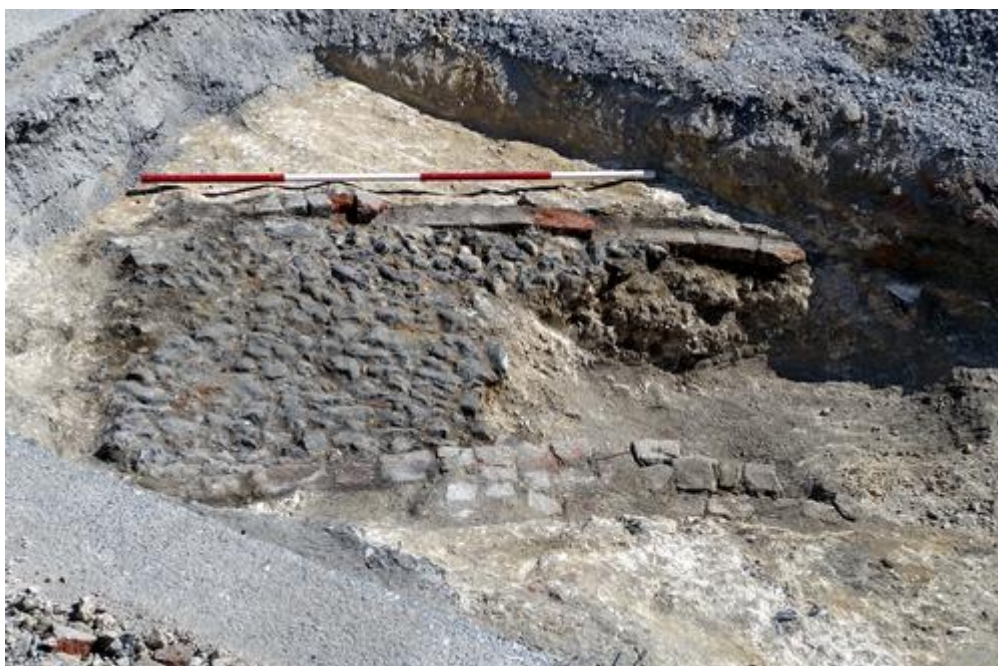
Immediately west of cellar 1005, a fragment of a curving trackway was preserved, comprising a cobblestone surface (814) bordered by red brick walls (811 and 812; Figure 16). This trackway does not correlate directly with consulted historic maps but probably provided access to a small rear yard mapped in 1866 ([Figure 5](#)).

Figure 16: Cobble surface 814 surrounded by walls 811 and 812. 1 x 2m scale. View from west

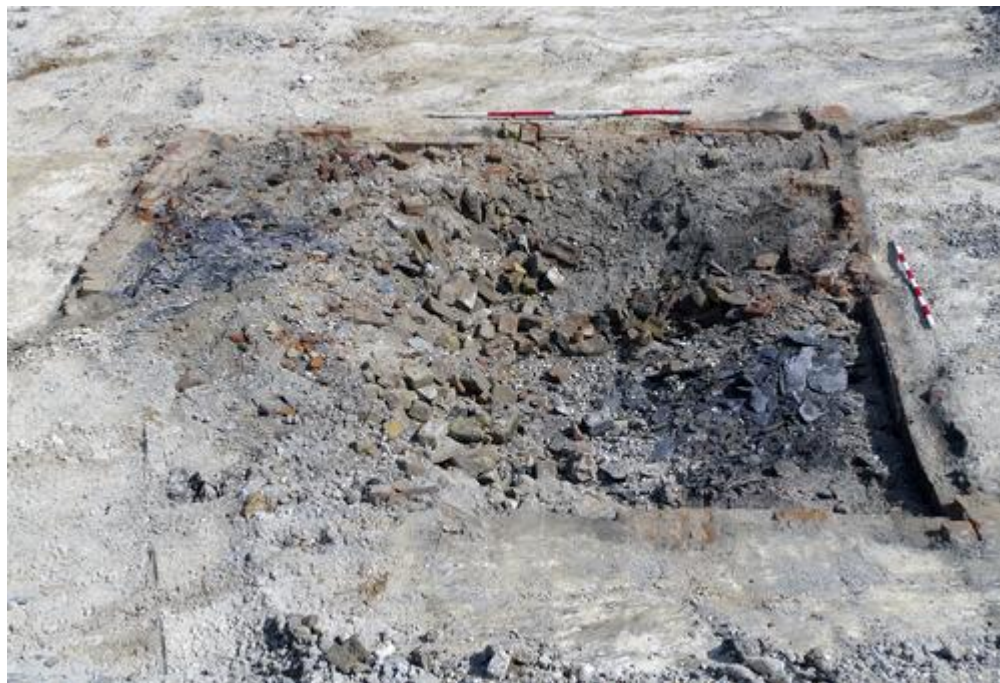
Further east was the third cellar (1042; Figure 17), comprising red and yellow bricks. It had been plastered on the inside. A small interior spur wall in the south-east corner might

represent the location of a staircase or the foundation of a ground floor passageway leading to the rear yard. This house was cleared during the expansion of the market ([Section 2](#) - expansion of the market), between 1909 ([Figure 8](#)) and 1932 ([Figure 9](#)).

Figure 17: Cellar 1042. 1 x 1m scale, 1 x 2m scale. View from west

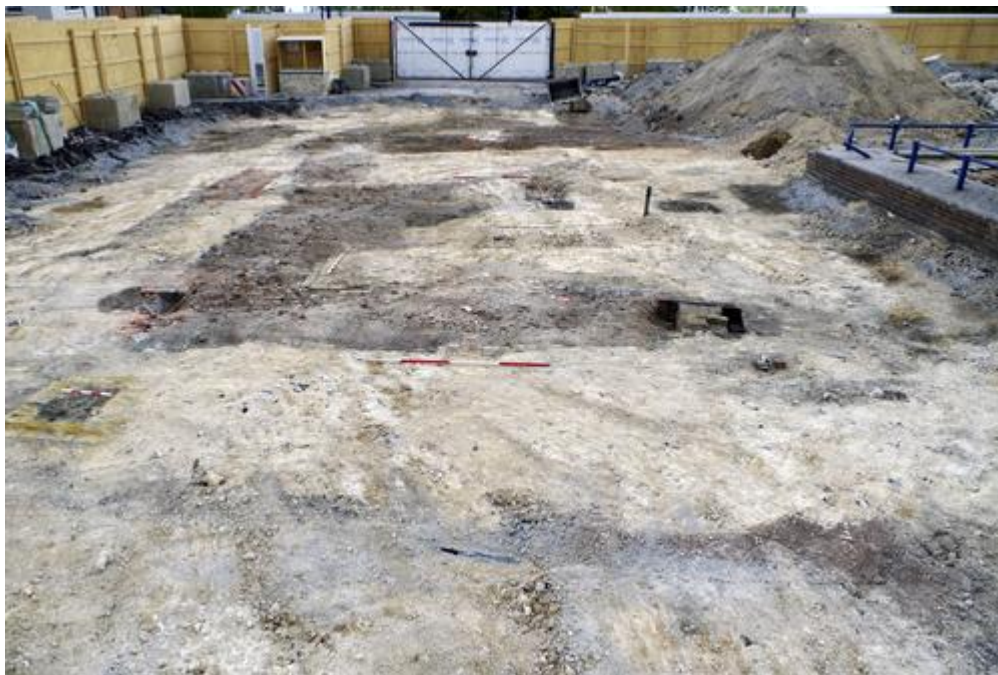
North of Swan Yard was another series of brick cellar walls (1240), relating to a small courtyard that was perhaps depicted as early as 1840 ([Figure 4](#)) and survived until at least 1933 when it appeared on an aerial photograph supplied by Tom Baines (pers. comm.; not reproducible). The photograph shows mostly single-storey brick buildings, with a two-storey building with chimneys to the east of the courtyard. West of the courtyard, cellar walls of plastered red and yellow bricks (1240; [Figure 18](#)) were revealed by excavation.

Figure 18: Cellar 1240. 2 x 1m scales, 2 x 2m scales. View from south

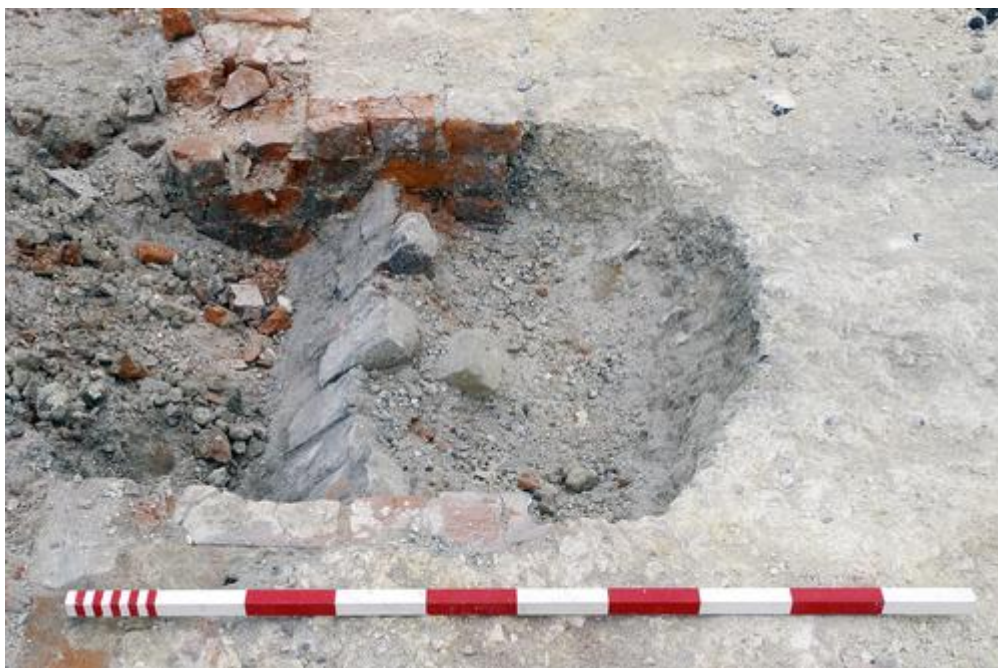
A coal chute (part of 1062, Figure 19) was present in the west of this cellar, accessible from an offshoot of Swan Yard ([Figure 5](#)).

Figure 19: Coal chute, part of 1062. 1 x 1m scale. View from north

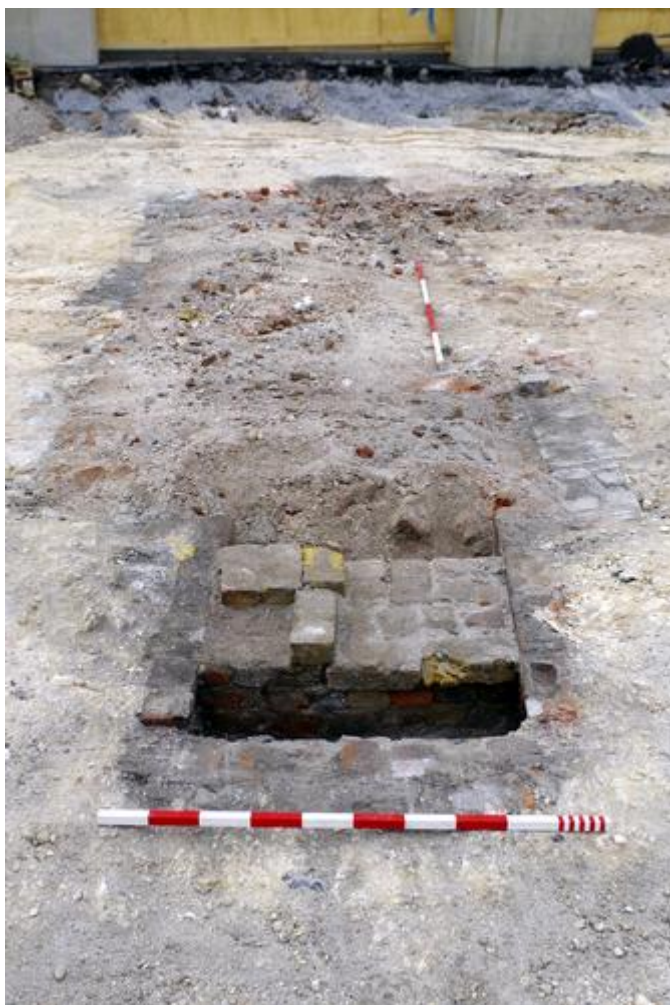
A staircase (1066; Figure 20) led east from the cellar into the courtyard. It was bricked up, suggesting that the cellar went out of use prior to demolition. Cesspits/wells 1056-1059, and tanks 1060 and 1076 were present in the yard ([Figure 10](#)) ([Section 4](#)).

Figure 20: Staircase 1066. 1 x 1m scale, 1 x 2m scale. View from east

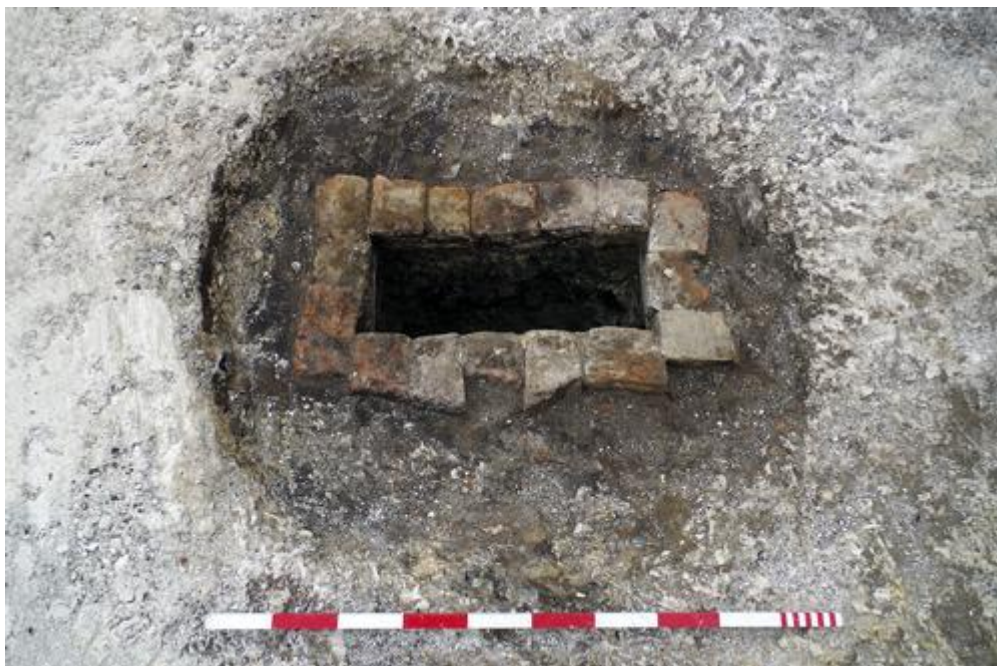
Figure 21: Pit 1188 and associated brick-lined structure. 1 x 1m scale. View from north

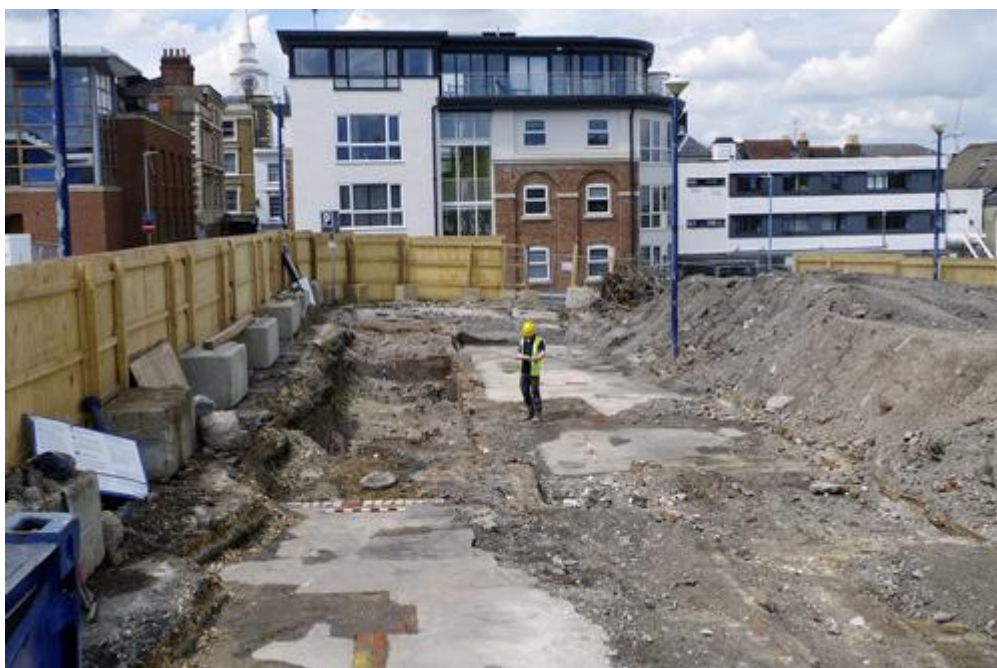
Figure 23: Working shot. In left of shot, cellars fronting Bank Street (1167, 1168, 1178, 1179=308 and 1182) with yard surface 1165 and wall 1166 in foreground. In right of shot, yard surfaces (1171, 1176 etc.) with house foundations 1169 and 1181 in foreground. 1 x 0.5m scale, 2 x 1m scales, 1 x 2m scale. View from east

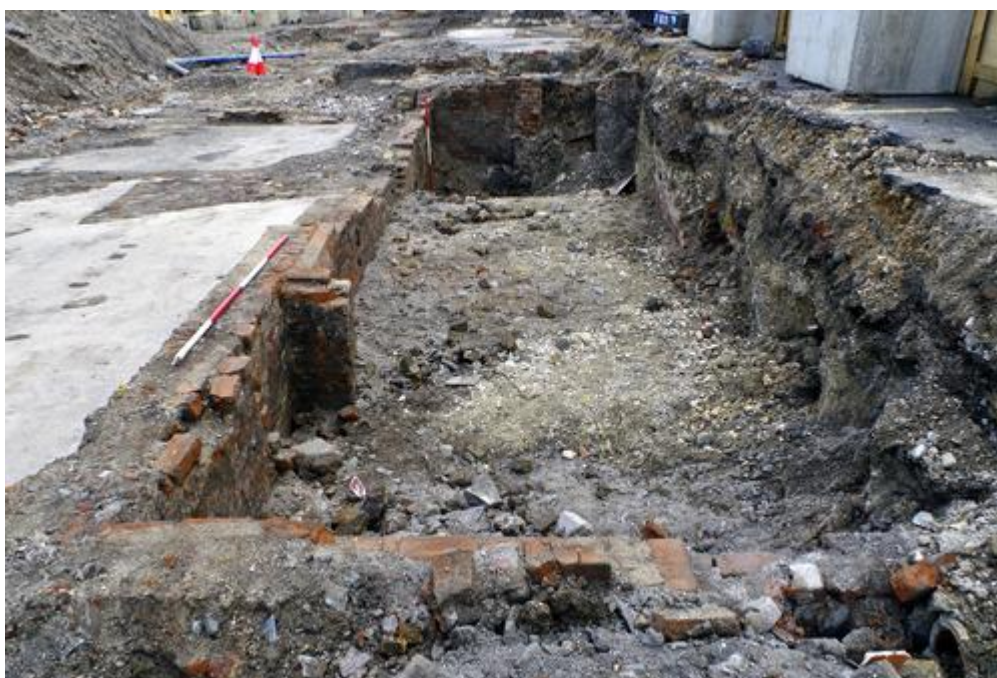
Figure 24: Cellar 1167 and 1168 partially excavated. 2 x 2m scales. View from west

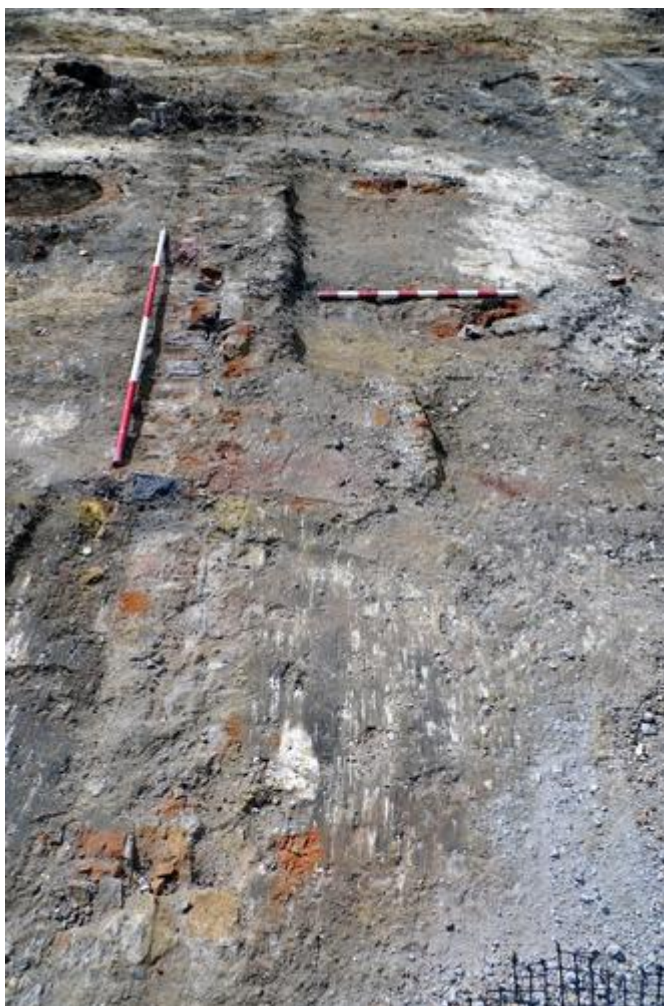
Figure 25: Coach works front range 1102 and 1103 (also cesspit/well 1092). 1 x 1m scale, 1 x 2m scale. View from east

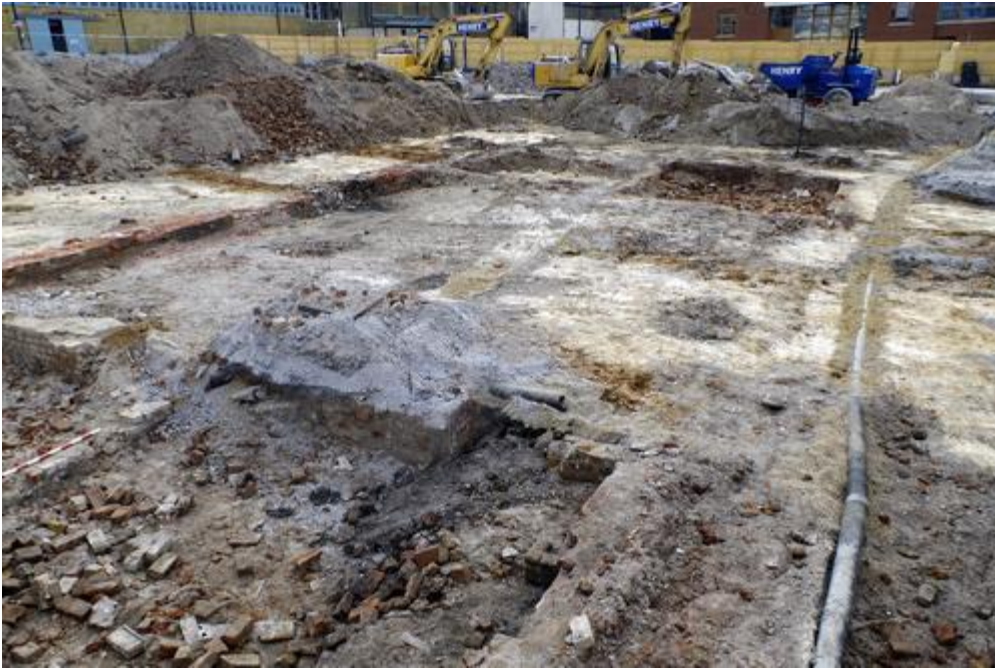
Two internally plastered red brick cellars of the east range also survived (1127, 1129; Figure 26).

Figure 26: Coach works east range cellars 1127 and 1129 (in foreground). View from north-east

These were respectively accessed by stairs in the west, into the courtyard, and south, into another building. Elsewhere, the basal course of three dissimilar red brick pads or piers were revealed (1080, 1077, 1088; Figure 27), built within larger construction cuts. They may have been machine bases and were located in a single building mapped in the south-east of the works. A small fragment of another truncated structure (1081), perhaps another base, was preserved in the south of the works. Three cesspits/wells (1090, 1091 and 1092) were located in the courtyard ([Figure 10](#)).

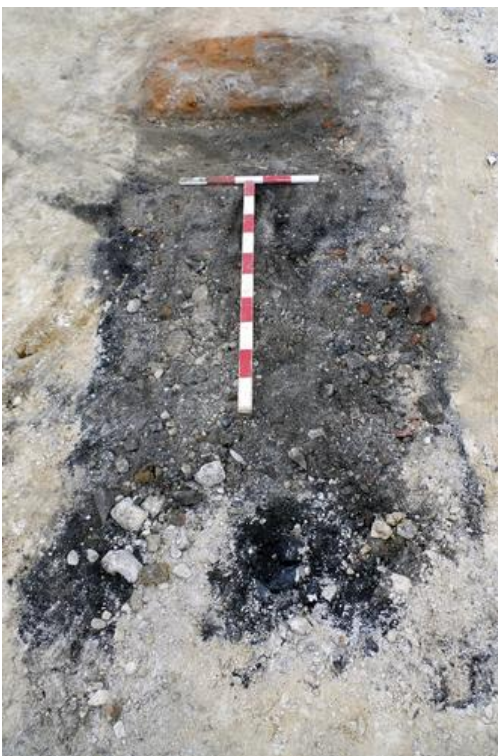
Figure 27: Machine base 1077 within larger construction cut 1078. 1 x 0.5m scale, 1 x 1m scale. View from north

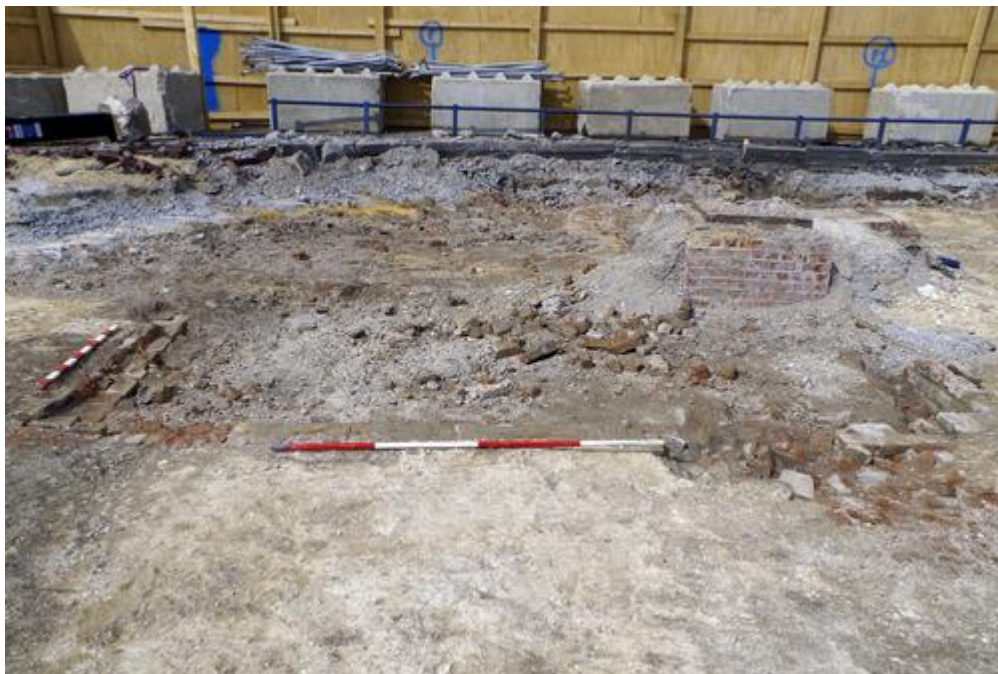
The truncated remains of the red brick cellar of this building were revealed (1101; Figure 28).

Figure 28: Cellar 1101 (8 Bank Street). 1 x 1m scale, 1 x 2m scale. View from south

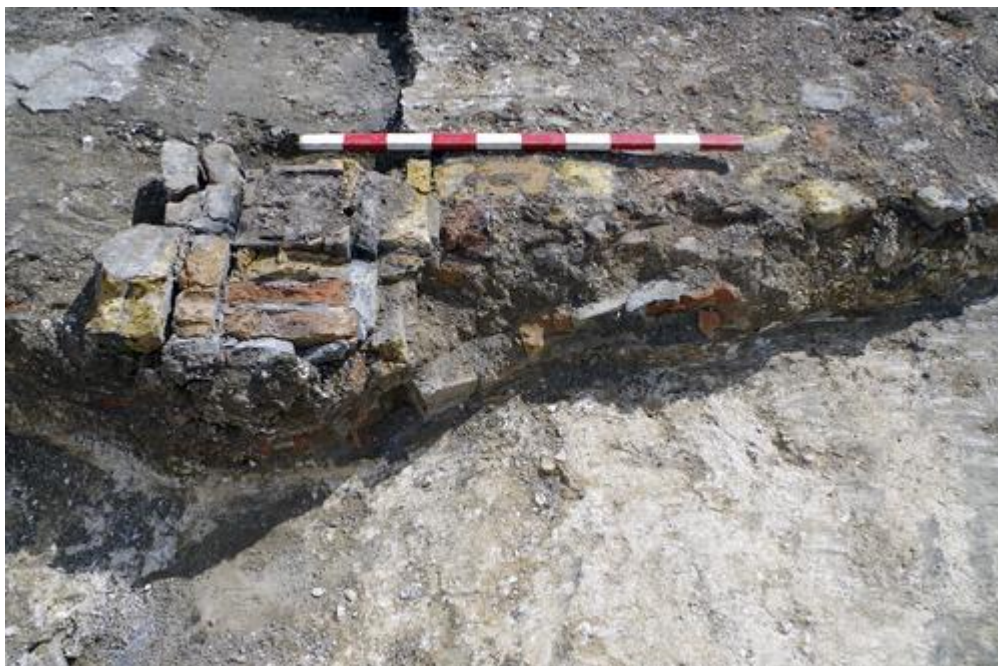
At the rear of cellar 1101 was a small yard, where the remnants of a wall (1094) and fragments of the flagstone yard surface (1095) survived. Wall 1094 (Figure 29) comprised red and yellow bricks ([Section 1.7](#)) laid with a curving face, and contained a vertical ceramic drain ([Section 4](#)). The drain may have been part of a privy and/or carried surface water. The 1933 aerial photograph shows that this house was a two-and-a-half or three storey brick townhouse with six chimney pots on its eastern gable and more at the west, suggesting some level of internal comfort. The yard cannot be seen in the image.

Figure 29: Wall 1094 at rear of 8 Bank Street. 1 x 1m scale. View from north

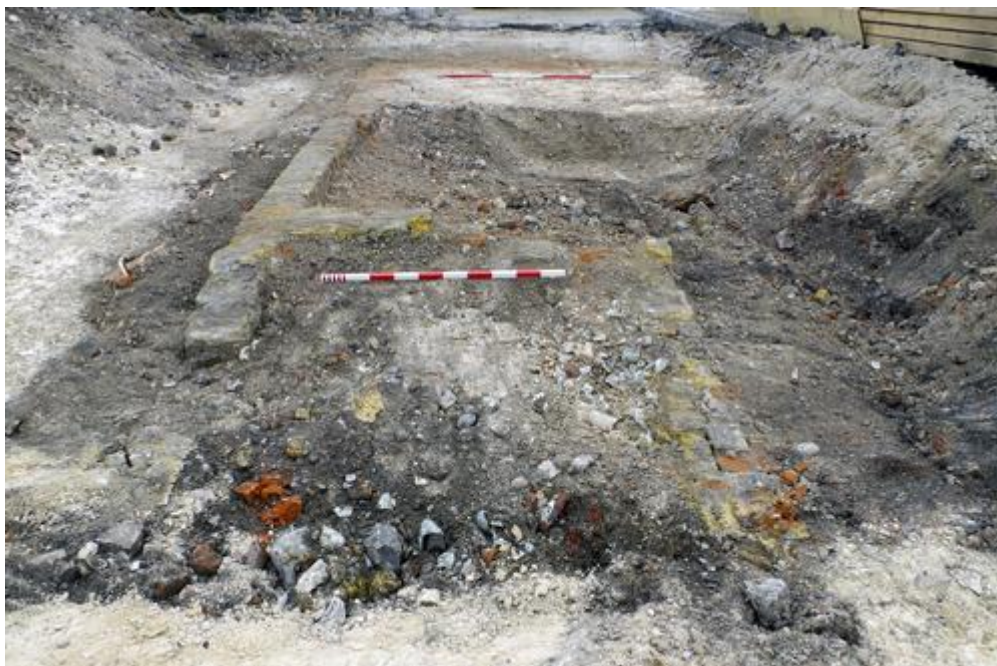
Figure 30: Foundation 1238. 1 x 1m scale, 1 x 2m scale. View from north

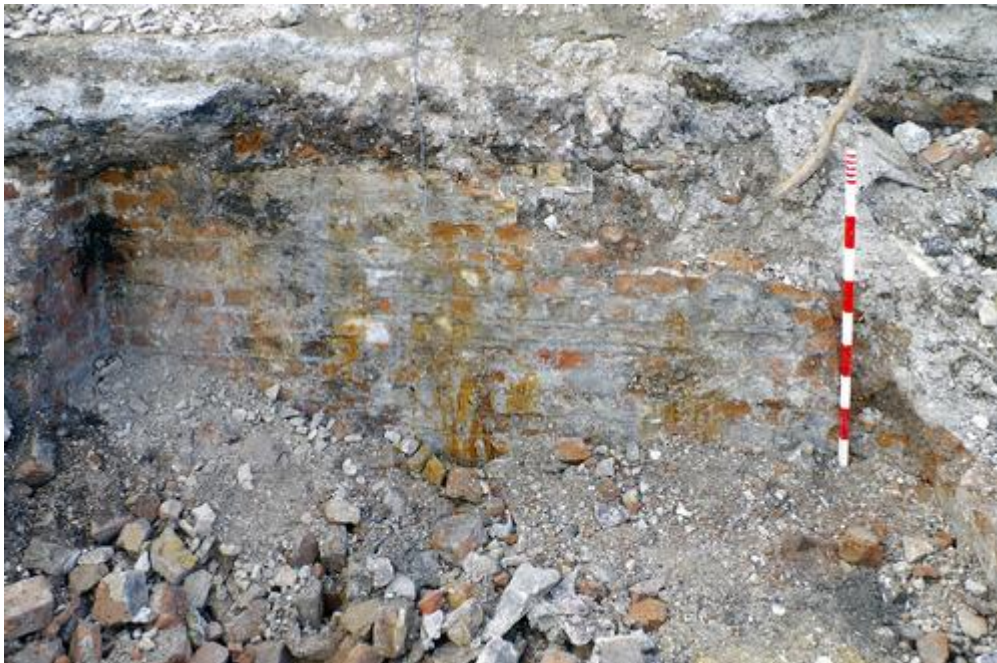
Figure 31: Cellar 1220 on Bull Yard square. 1 x 1m scale. View from east

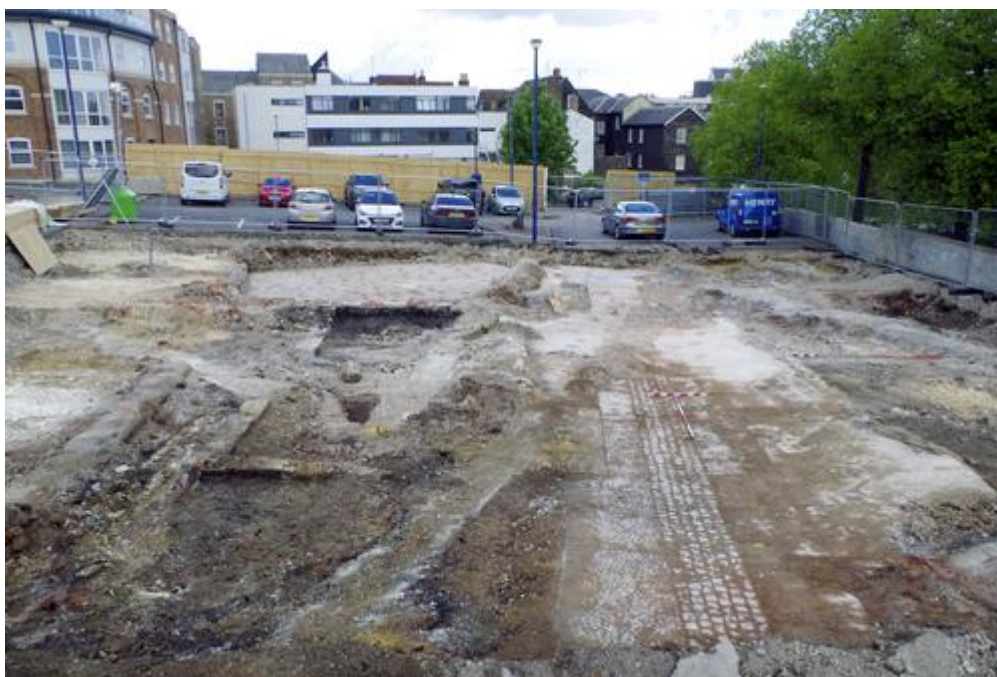
On the south side of Bull Yard were two dwellings, where the remains of the yellow plastered brick cellars were revealed (1135; Figure 32). These houses appear on the 1840 map

Figure 32: Cellars 1135 and 1148 (centre left of shot) with 20th-century surface of Bull Yard (centre right). 2 x 0.5m scales, 2 x 1m scales, 2 x 2m scales. View from east

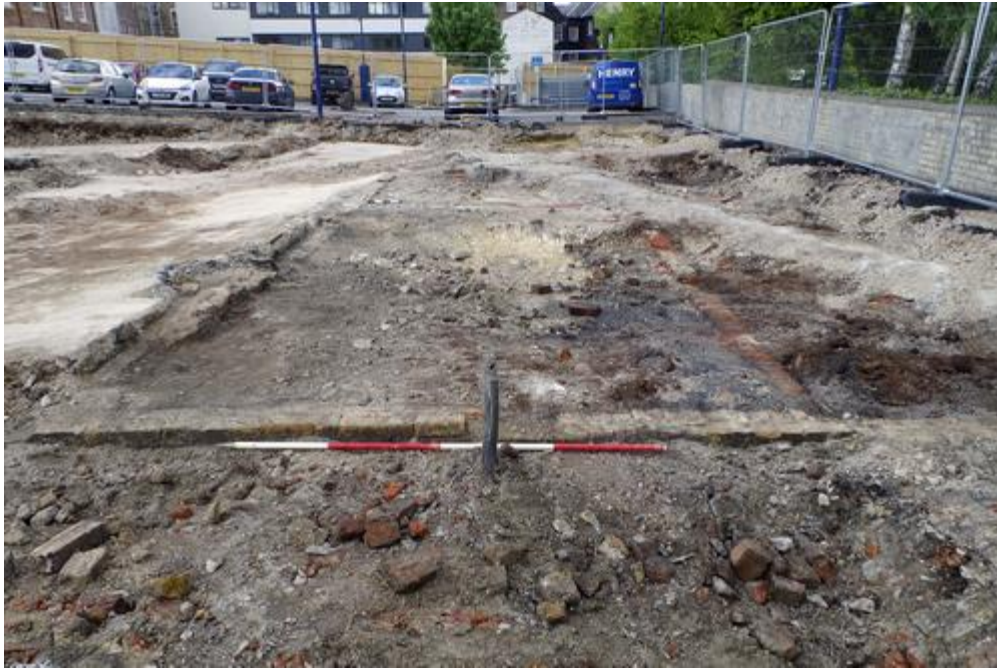
Figure 33: Cellars 1237 of terrace north of Bull Yard. 2 x 0.5m scales, 1 x 2m scale. View from east

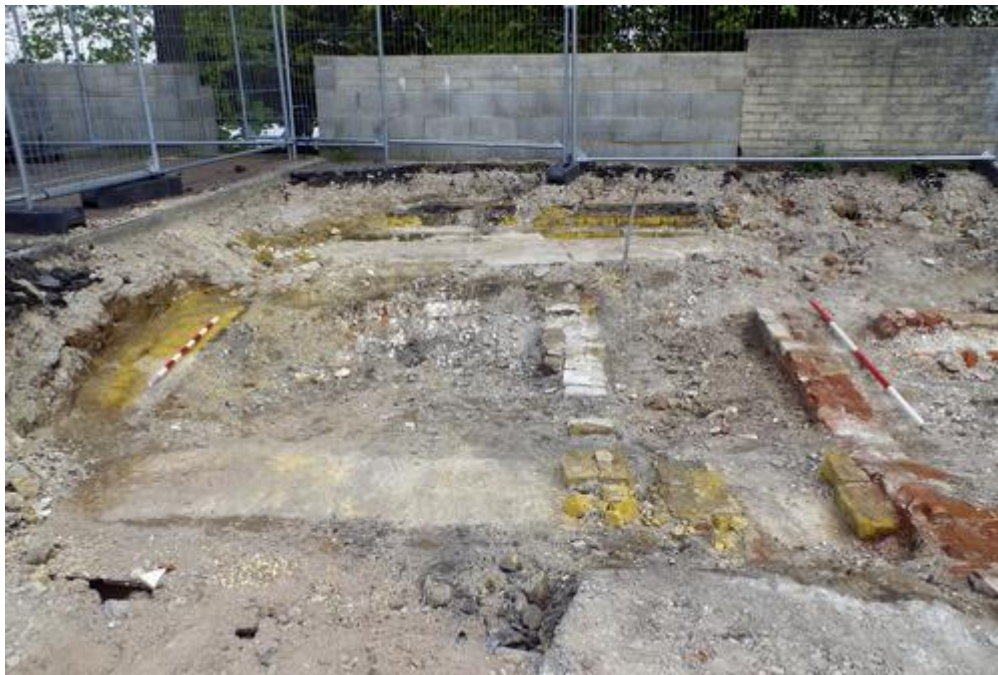
Figure 34: Extension 1139 (yellow brick) with main terrace 1140 (red brick) on right. 1 x 1m scale, 1 x 2m scale. View from south

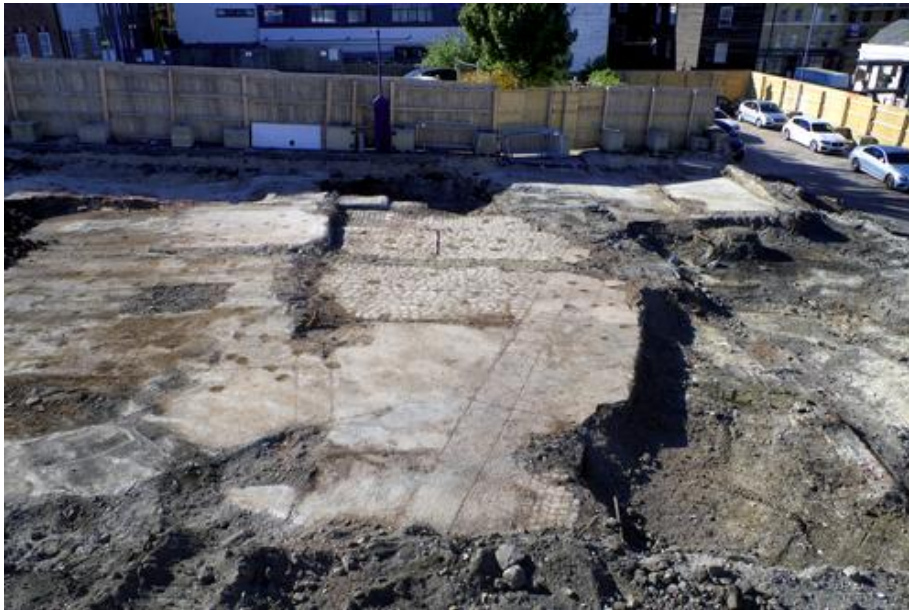
Figure 35: Surfaces of Bull Yard, including cobblestones 1221 (centre). 1 x 1m scale, 1 x 2m scale. View from east

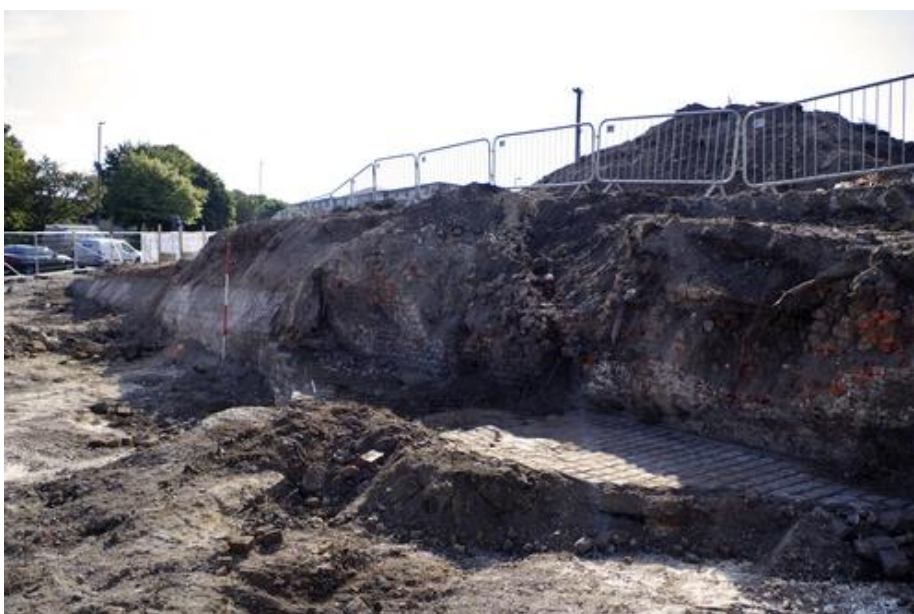
A major west to east red brick wall (1203/1210) divided the Bull Yard properties from those south of Crooked Lane. Wall 1203/1210 had been partly replaced with a 20th-century wall (1204), unusually constructed from repurposed (and potentially reused) granite setts and Portland cement (Figure 36). Most of the alignment of wall 1204 replaced that of the truncated 1203/1210; however, it curved north in the west. Wall 1204 was probably a late 20th-century landscaping feature, perhaps associated with the realignment of Crooked Lane and the early use of the site as a car park. The 1955 map ([Figure 22](#)) shows that the alignment of Crooked Lane had been altered slightly, although not to the extent it appears today, and it may be that wall 1204 was contemporary with this phase of redevelopment.

Figure 36: Red brick wall 1203/1210 replaced by unusual granite sett and Portland cement wall 1204. 1 x 0.5m scale, 1 x 2m scale. View from north-west

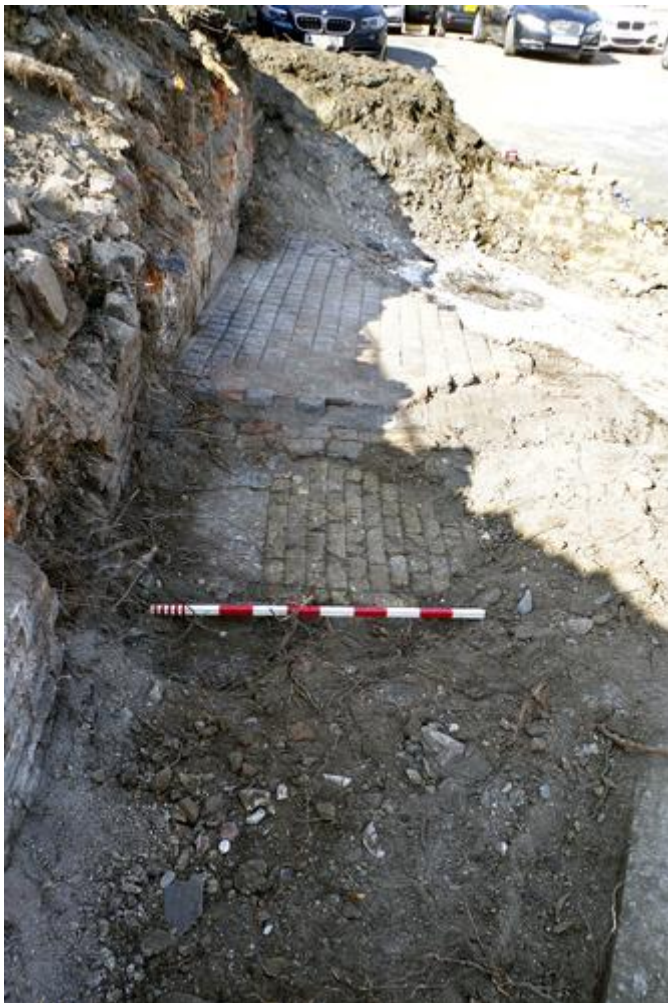
Figure 37: Yellow brick surface 1213, red brick wall 1210 and later textured concrete surface 1211. 1 x 1m scale. View from east

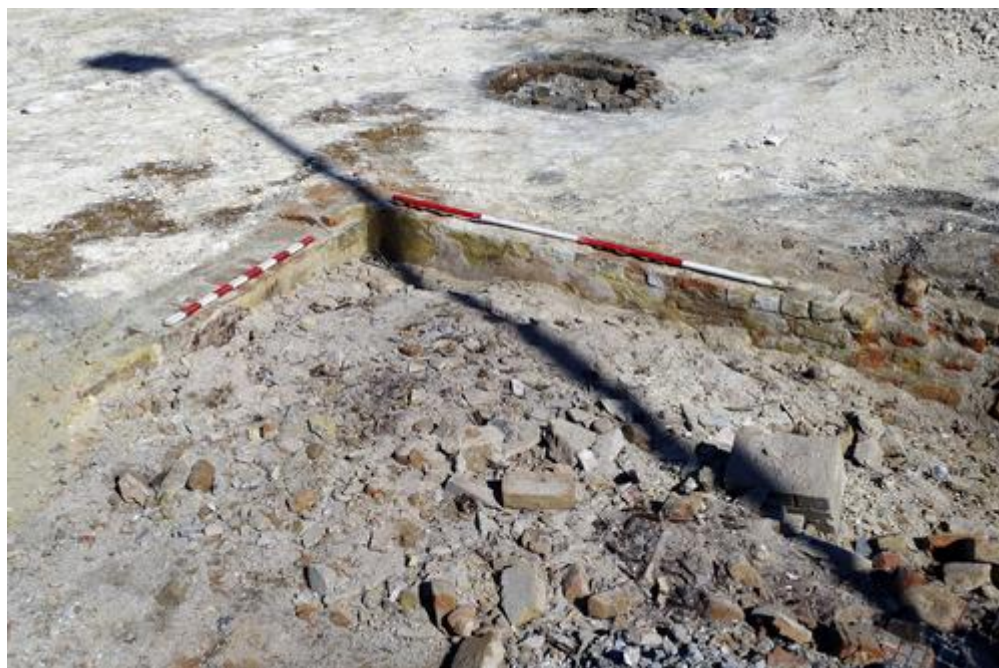
Figure 38: Cellar 1033 on Queen Street. 1 x 1m scale and 1 x 2m scale. View from south-east

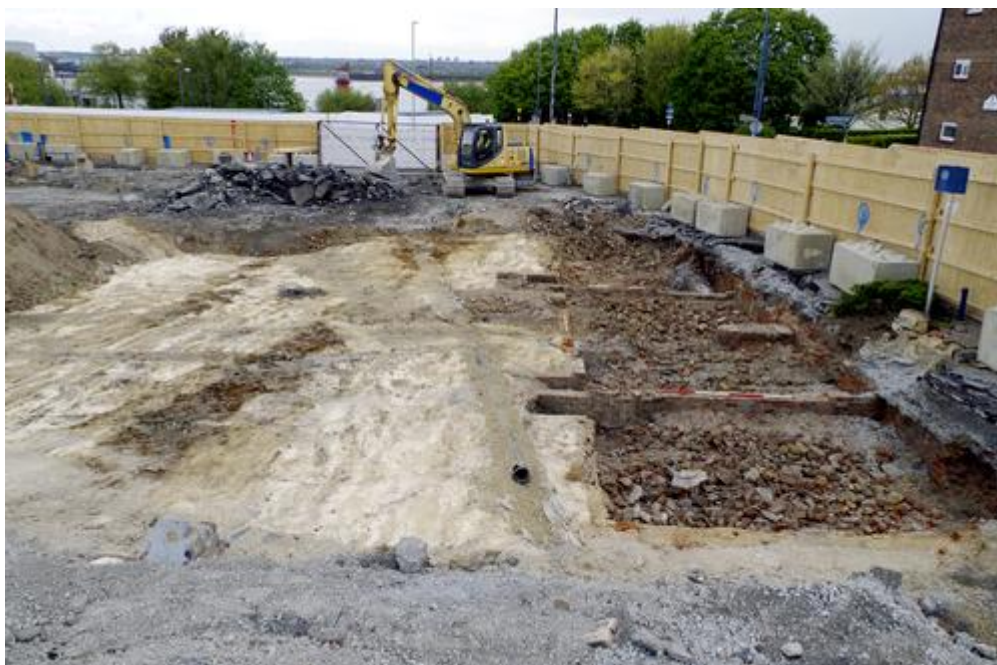
Figure 39: Cellars 1036=1112 and 1113-1117 fronting Queen Street. 1 x 1m scale, 2 x 2m scales. View from south

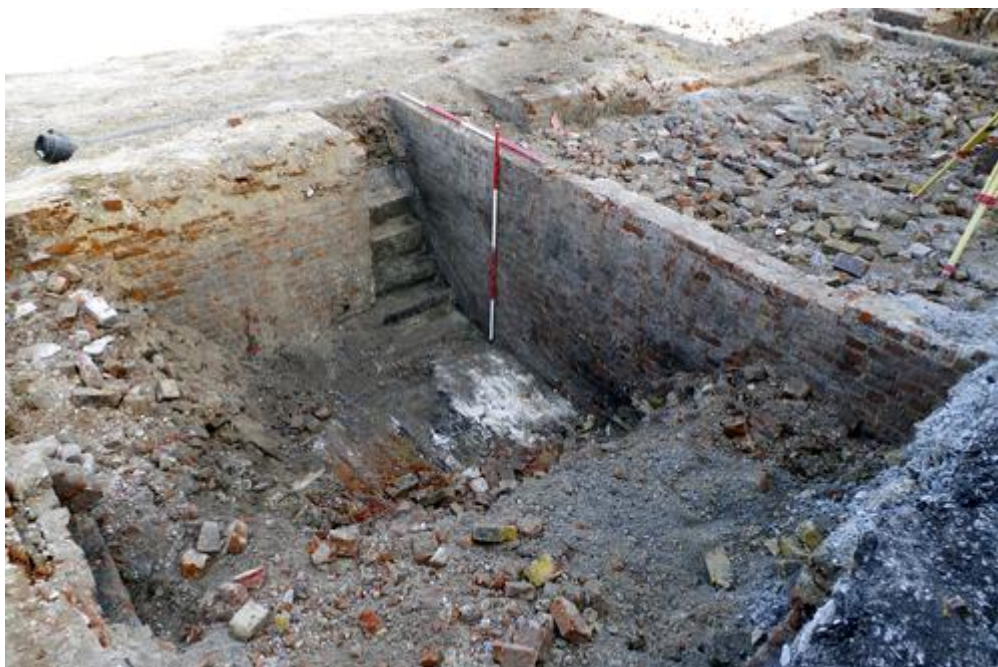
Figure 40: Cellar 1112 excavated to floor, showing concrete repair to stairs. 2 x 2m scales. View from south-east

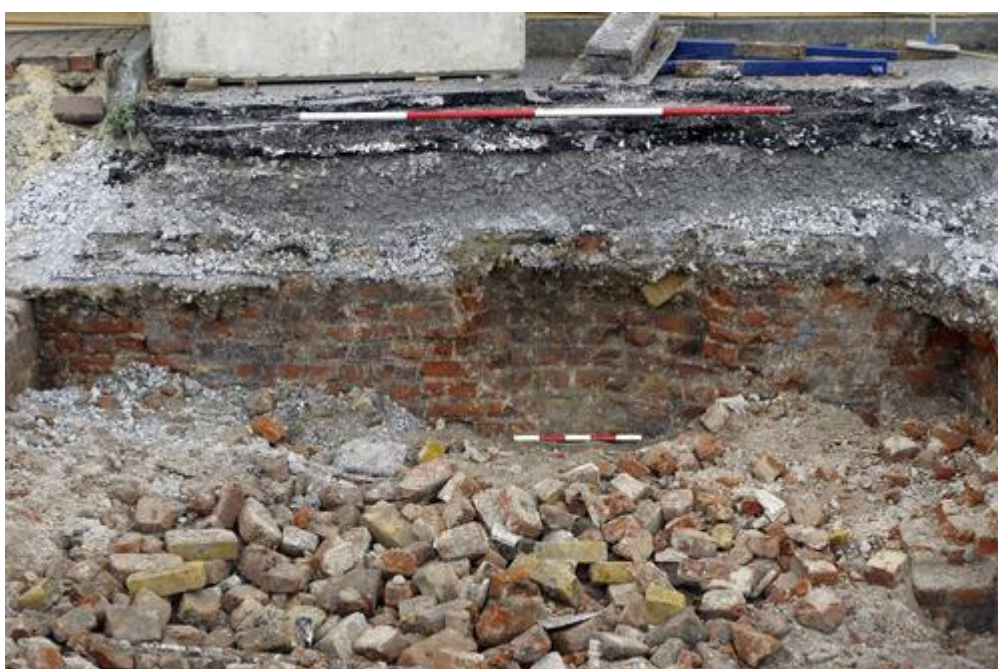
These walls incorporated the foundations of fireplaces at ground level, and a semi-circular recess (Figure 41) in wall 1113 was probably a coal chute. Access to each cellar was via straight stairs from the rear (i.e. under the rear rooms of the houses). In two houses, the stairs had been resurfaced with concrete, indicating repair in the 20th century (Figure 40). One of the houses was different in having a second cellar under the rear room (1115=610), built in identical materials to the main cellars and therefore probably original, although these materials had a long currency. These houses continued to be mapped until at least 1955 ([22](#)), when they were numbered 33-41.

Figure 41: Coal chute in cellar wall 1113. 1 x 0.5m scale, 1 x 2m scale. View from west

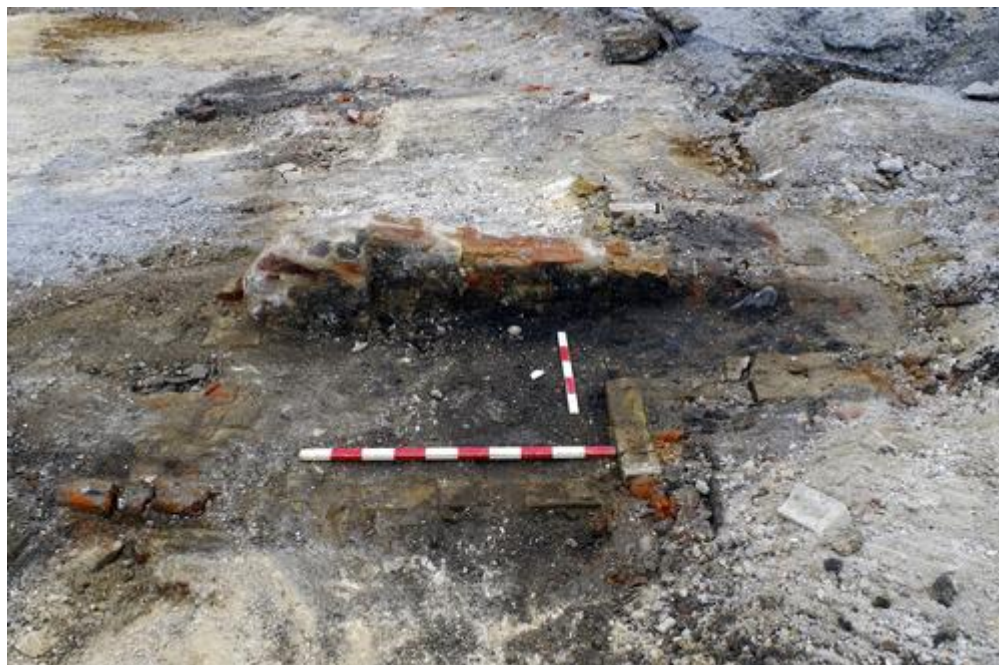
Figure 42: Privy 1084. 1 x 0.5m scale, 1 x 1m scale. View from south
