# 'A State of Things Which Ought Not to be Permitted': Excavation of 19th-century slums (Bull Yard, Horn Yard, Swan Yard and Market Alley) surrounding Bank Street at 'The Charter', Gravesend

*Ashley Tuck*

Nineteenth-century remains in Gravesend (Kent, UK) were revealed by excavation, chiefly comprising buildings, along with wells and cesspits. Historic maps, newspaper archives and other sources have been used to interpret the majority of the site as a low status 'slum' accessed from narrow pedestrian passageways (Bull Yard, Horn Yard, Swan Yard and Market Alley). These areas comprised a poorly planned mixture of dwellings and premises including slaughterhouses, piggeries, warehouses and other commercial and small-scale industrial properties. A newspaper account described a view of the interiors of dwellings glimpsed through broken windows on Market Alley as 'A state of things which ought not to be permitted' (Gravesend and Dartford Reporter, 12 July 1879). Some parts of the site (Bank Street and Queen Street) were occupied by higher status dwellings and premises, including a medium-sized coach factory.

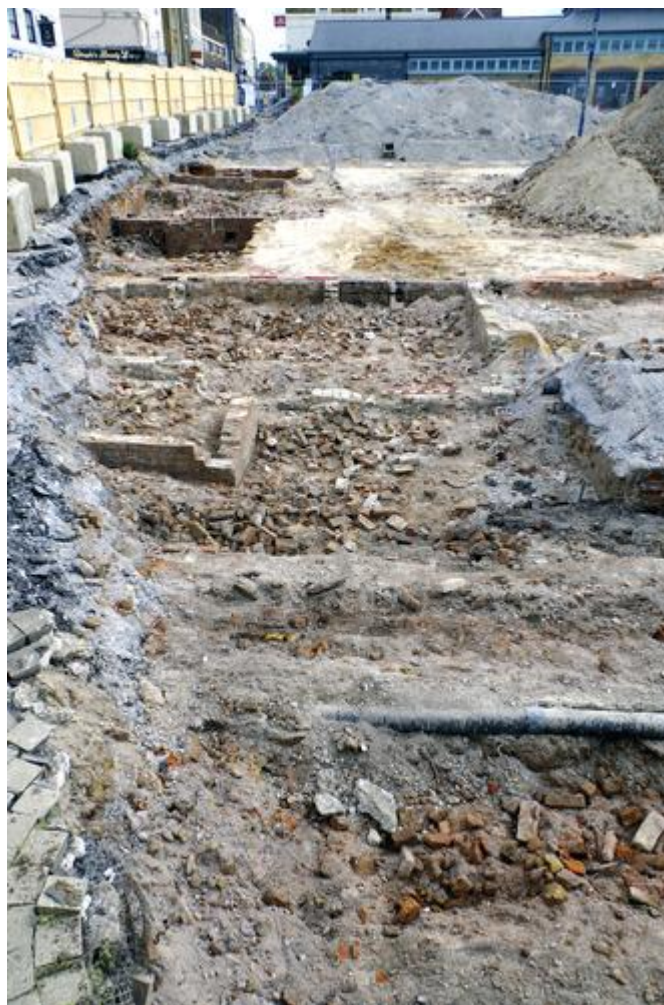
Figure 43: Cellars 1119-1121. 2 x 2m scales. View from north
