## Late Iron Age/Romano-British Transition Pastoral Activity in the Western Environs of York: Archaeological investigations at the A1237/B1224, Wetherby Road Roundabout, York

### Summary

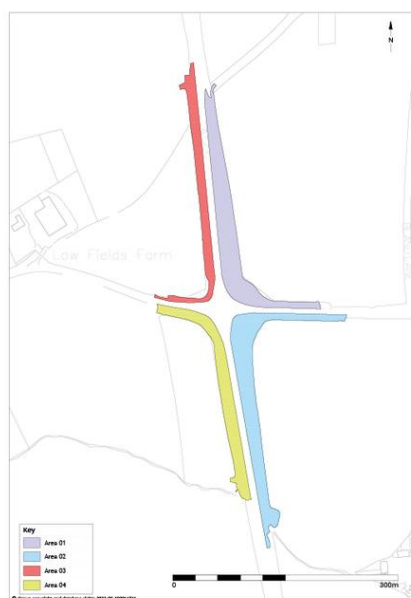
Figure 2: Plan of Areas 1–4

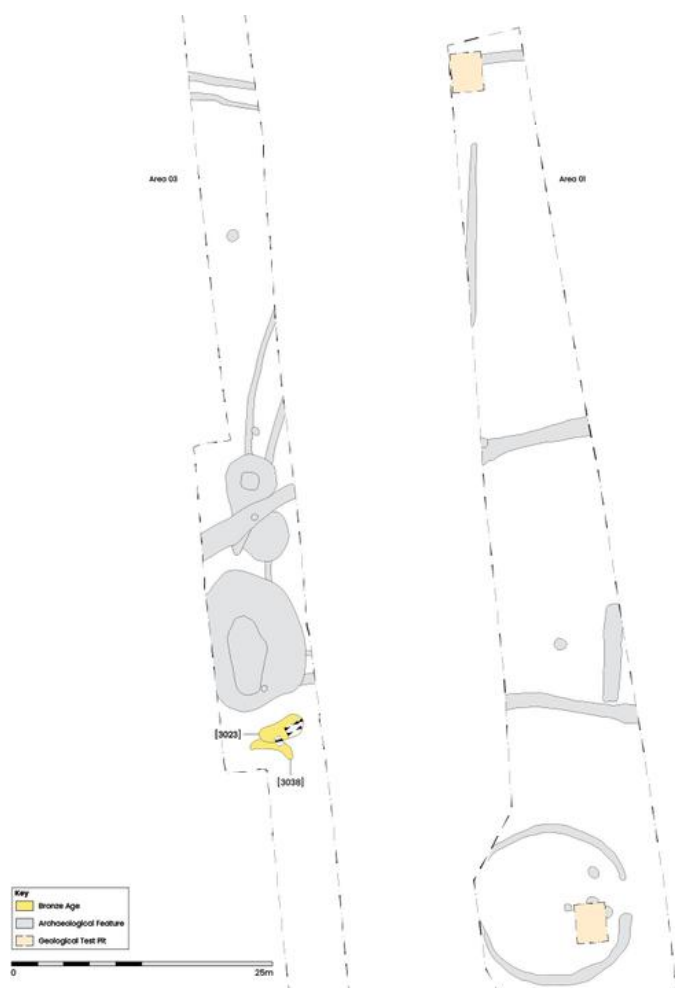
Figure 4: Phase 2 features

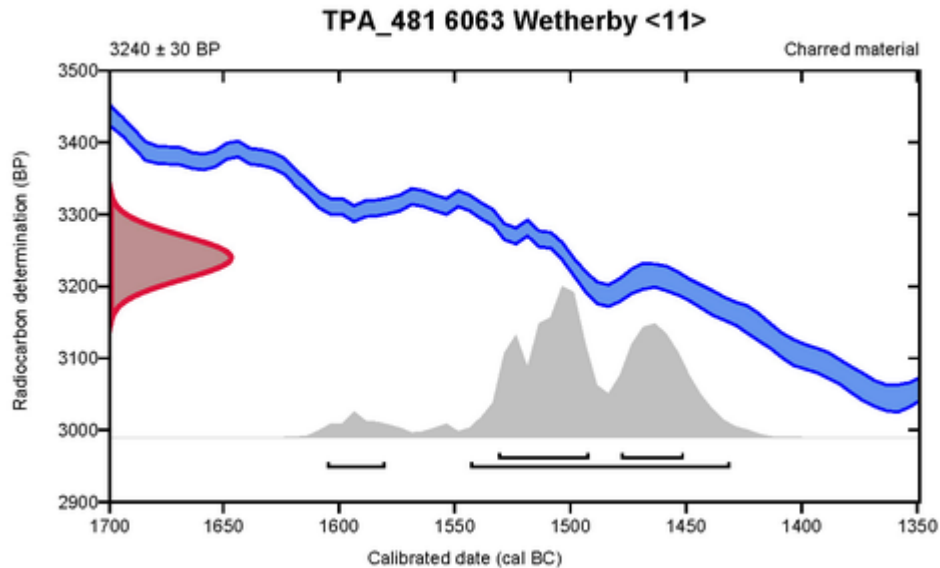
Figure 5: Pit fill (3022) radiocarbon date

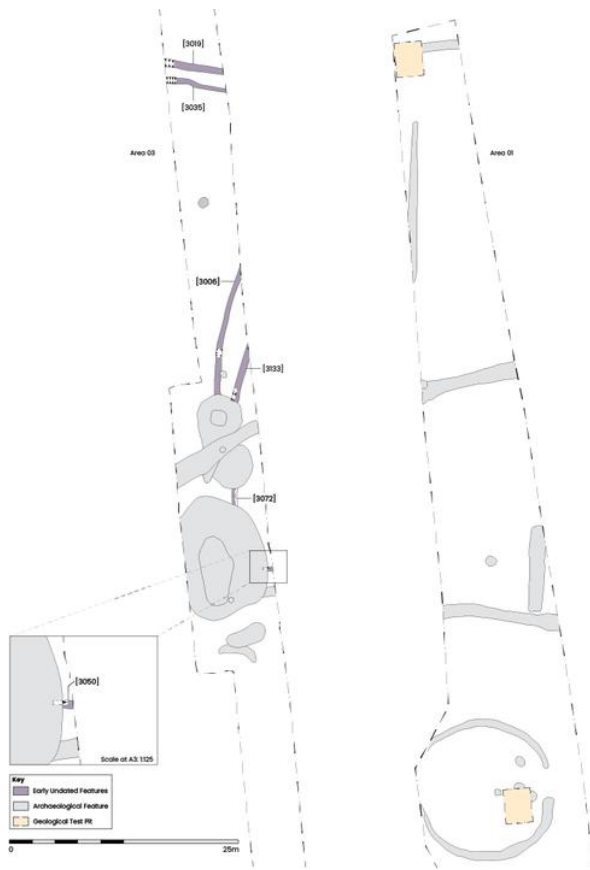
Figure 6: Phase 3 features

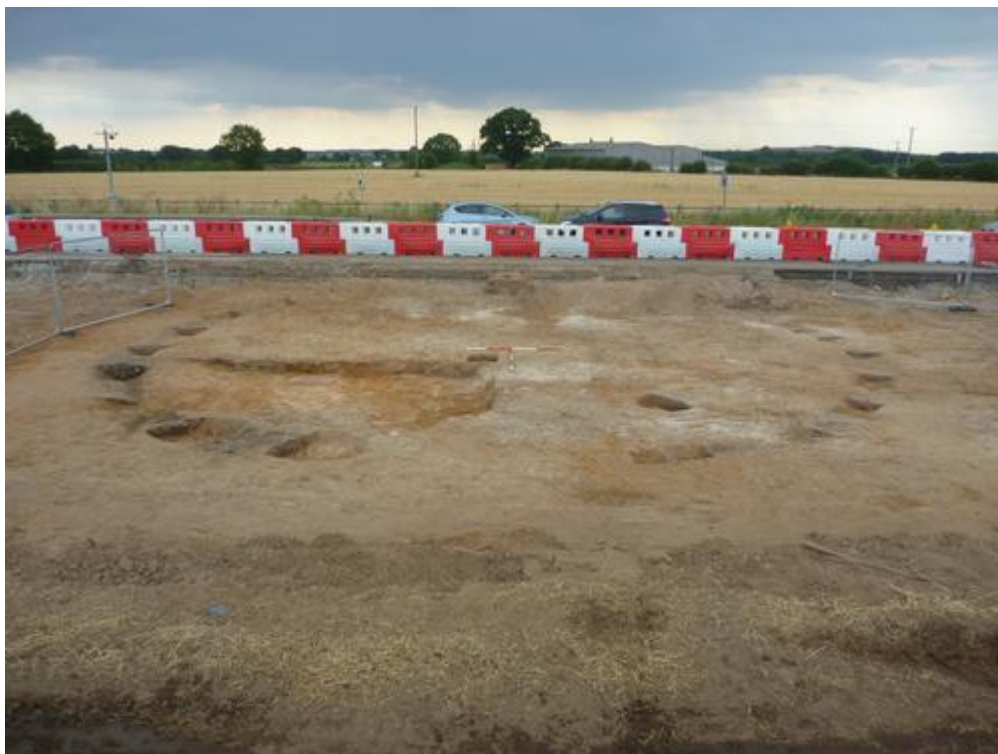
Figure 8: Ring-gully enclosure, facing west. 0.5m scale units. Image credit: York Archaeology

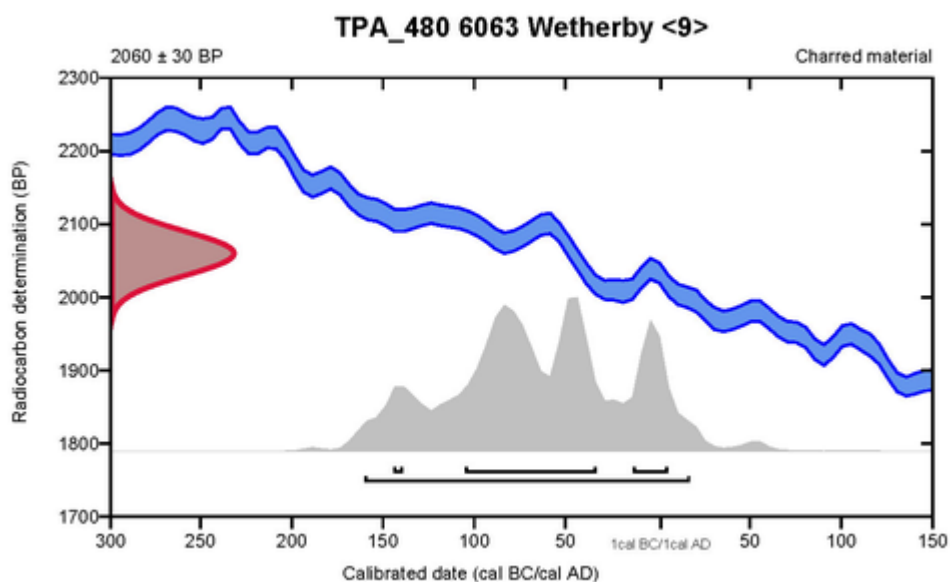
Figure 10: Pit fill (1087) radiocarbon date

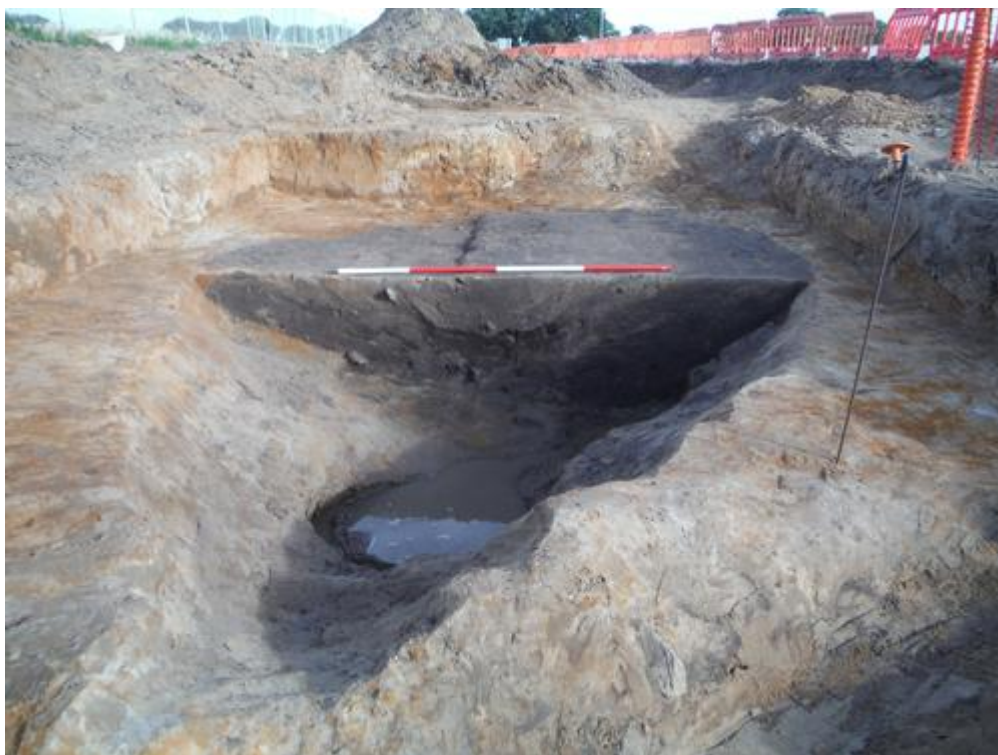
Figure 14: Watering hole [3179], facing north. 0.5m scale units. Image credit: York Archaeology

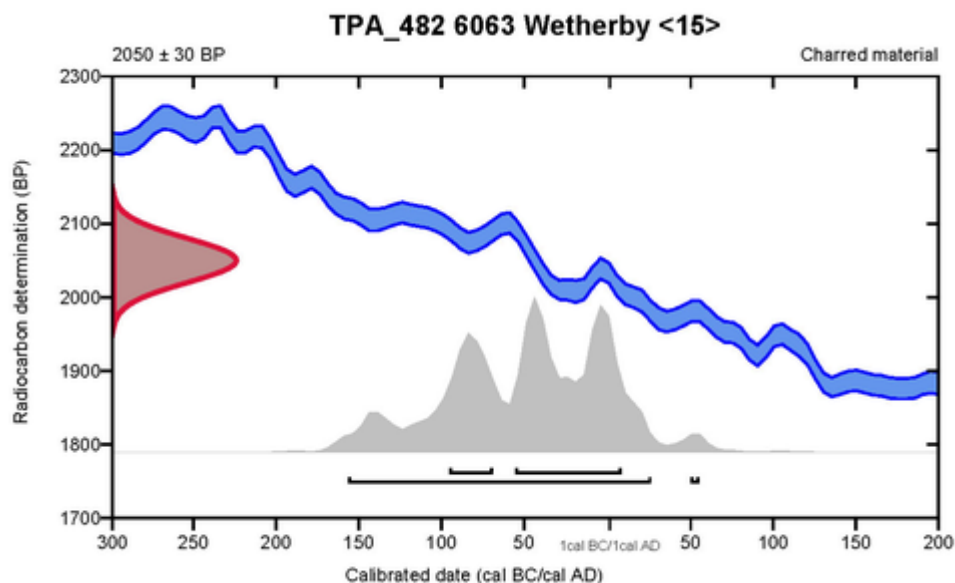
Figure 19: Watering hole fill (3171) radiocarbon date

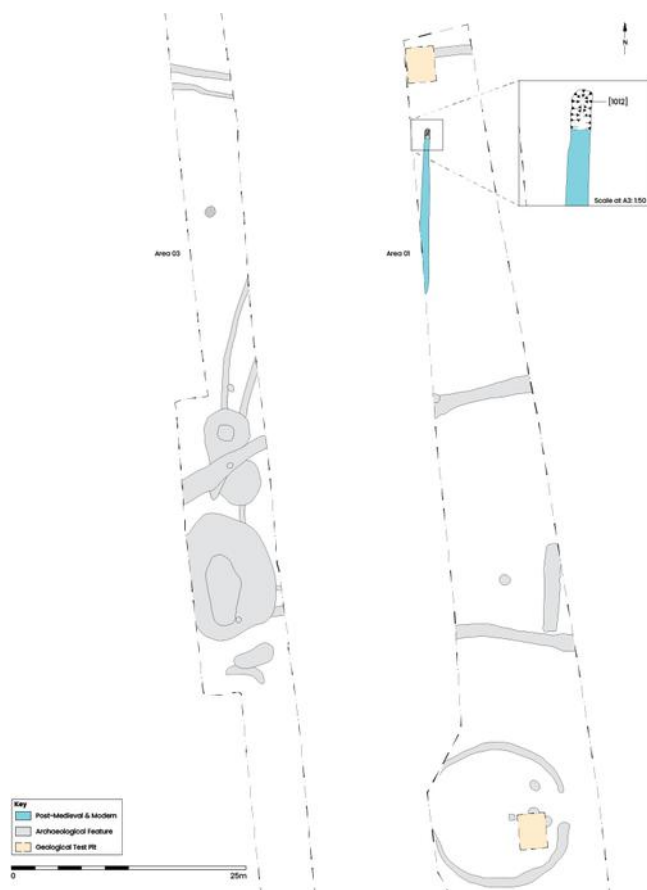
Figure 20: Phase 6 features

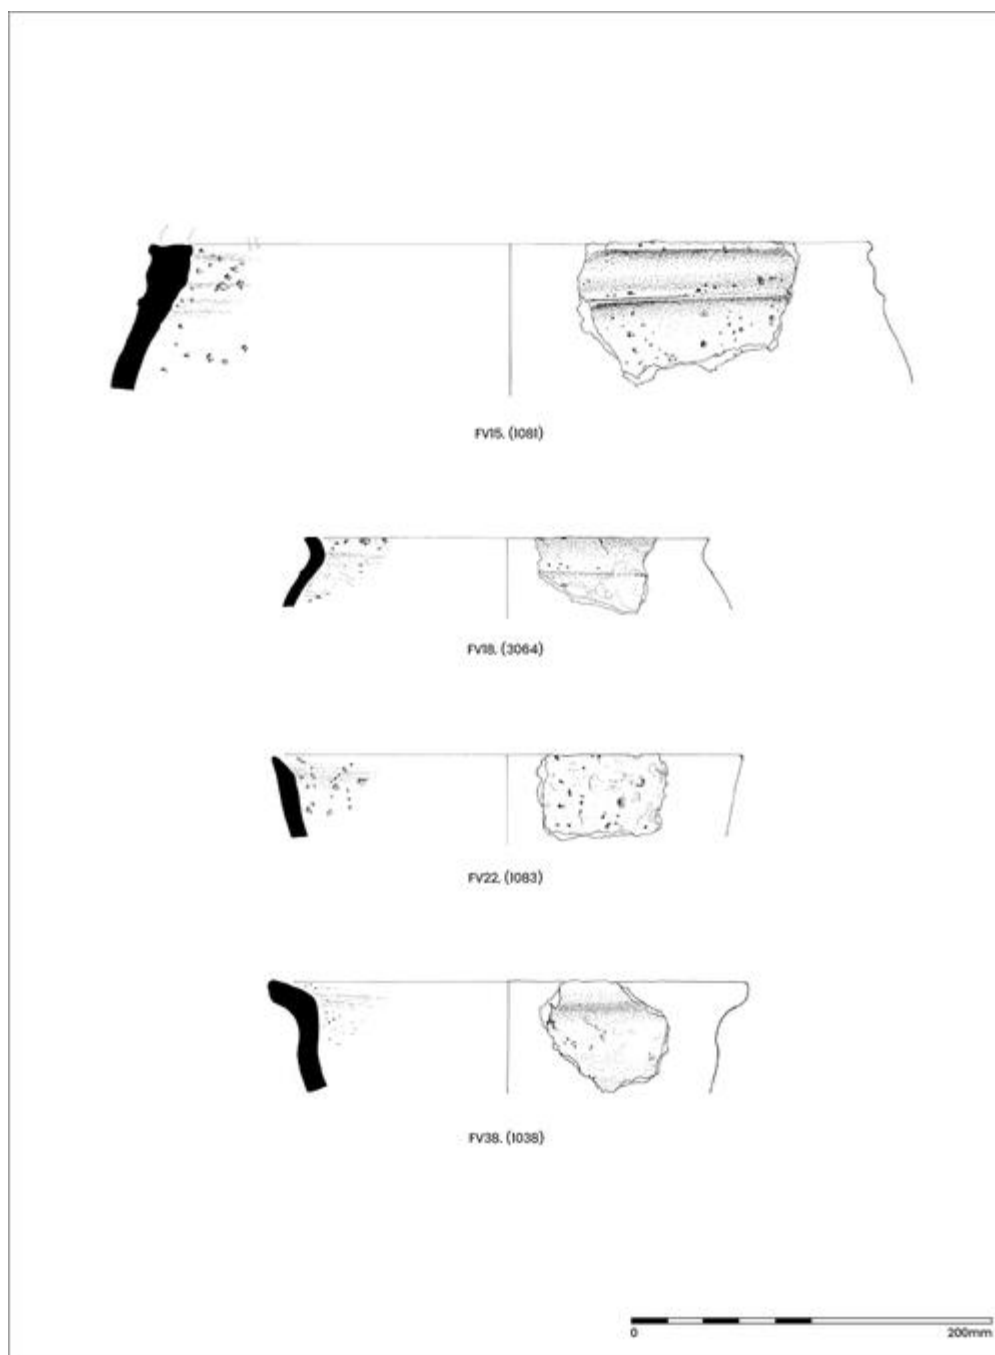
Figure 21: Prehistoric vessel forms (illustrated by R. Duffield)

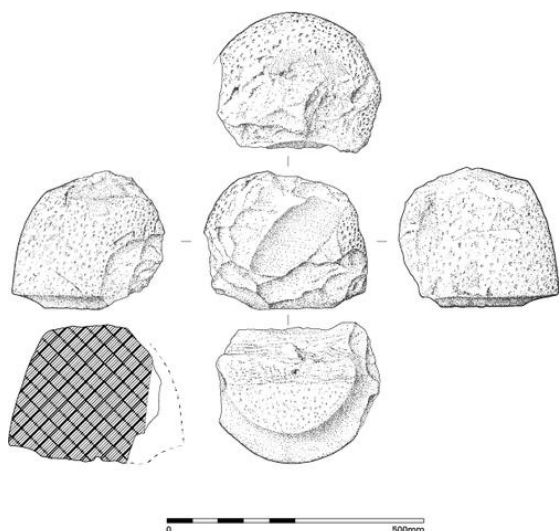
Figure 25: Beehive quern roughout. (3143), SF17 (illustrated by L. Collett)
